# Manhole Inspection Summary

Manhole # S53O\_\_007MH

Insp Date: **4/16/08 9:20 AM**

**Location** Address: **3111 odonnell street**

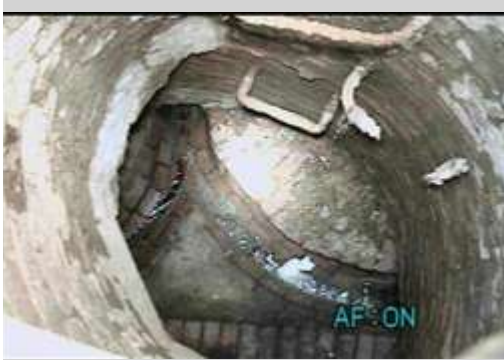
Defect 1

Infiltration: ☐ None ☐ Joint ☐ Cracks ☐ Mortar ☐ Roots ☒ **Wall**

**Steps** Count: **4** Missing: **1** ☒ **Corroded**

Corroded Steps, Barrel and Corbel  
Infiltration,

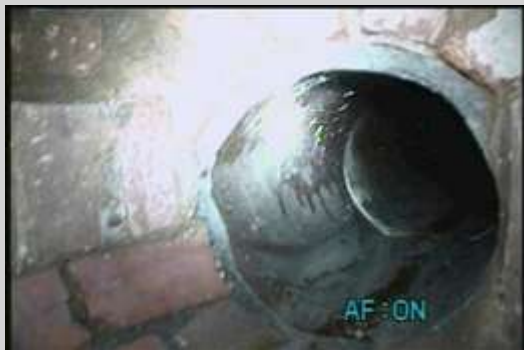
12 O'Clock Outflow

8 in. Circular Gravity Sewer  
Pipe Out @ 12 O'Clock

Invert Depth: 8.00 (ft.) Flow Characteristics: **Slow**

Infiltration: **None** Pipe Seal Cond: **Unknown**

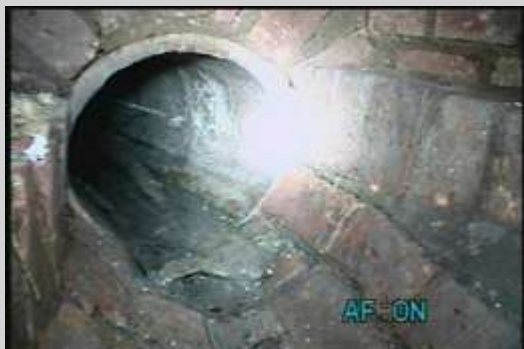
3 O'Clock Inflow

8 in. Circular Gravity Sewer  
Pipe In @ 3 O'Clock

Invert Depth: 7.50 (ft.) Flow Characteristics: **Slow**

Infiltration: **None** Pipe Seal Cond: **Unknown**

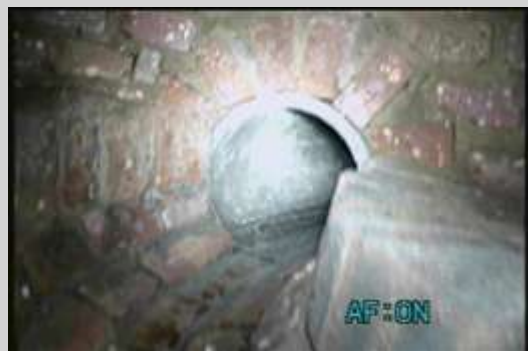
9 O'Clock Inflow

8 in. Circular Gravity Sewer

Pipe In @ 9 O'Clock

Invert Depth: **7.80** (ft.) Flow Characteristics: **Slow**

Infiltration: **None** Pipe Seal Cond: **Unknown**
